THE CLIMATE BEHIND PICTURES MOUNTED AGAINST THE OUTER WALLS OF THE CHAPEL OF LEDREBORG, DENMARK

Tim Padfield and Annabel Robinson

This is a digital version of the article first published as: Tim Padfield and Annabel Robinson, 'The climate behind pictures mounted against the outer walls of the chapel of Ledreborg, Denmark', Preprints of the ICOM (International Council of Museums) Committee for Conservation, Edinburgh meeting, 1966 pp 72-75.

Tim Padfield*
Conservation Department
The National Museum of Denmark

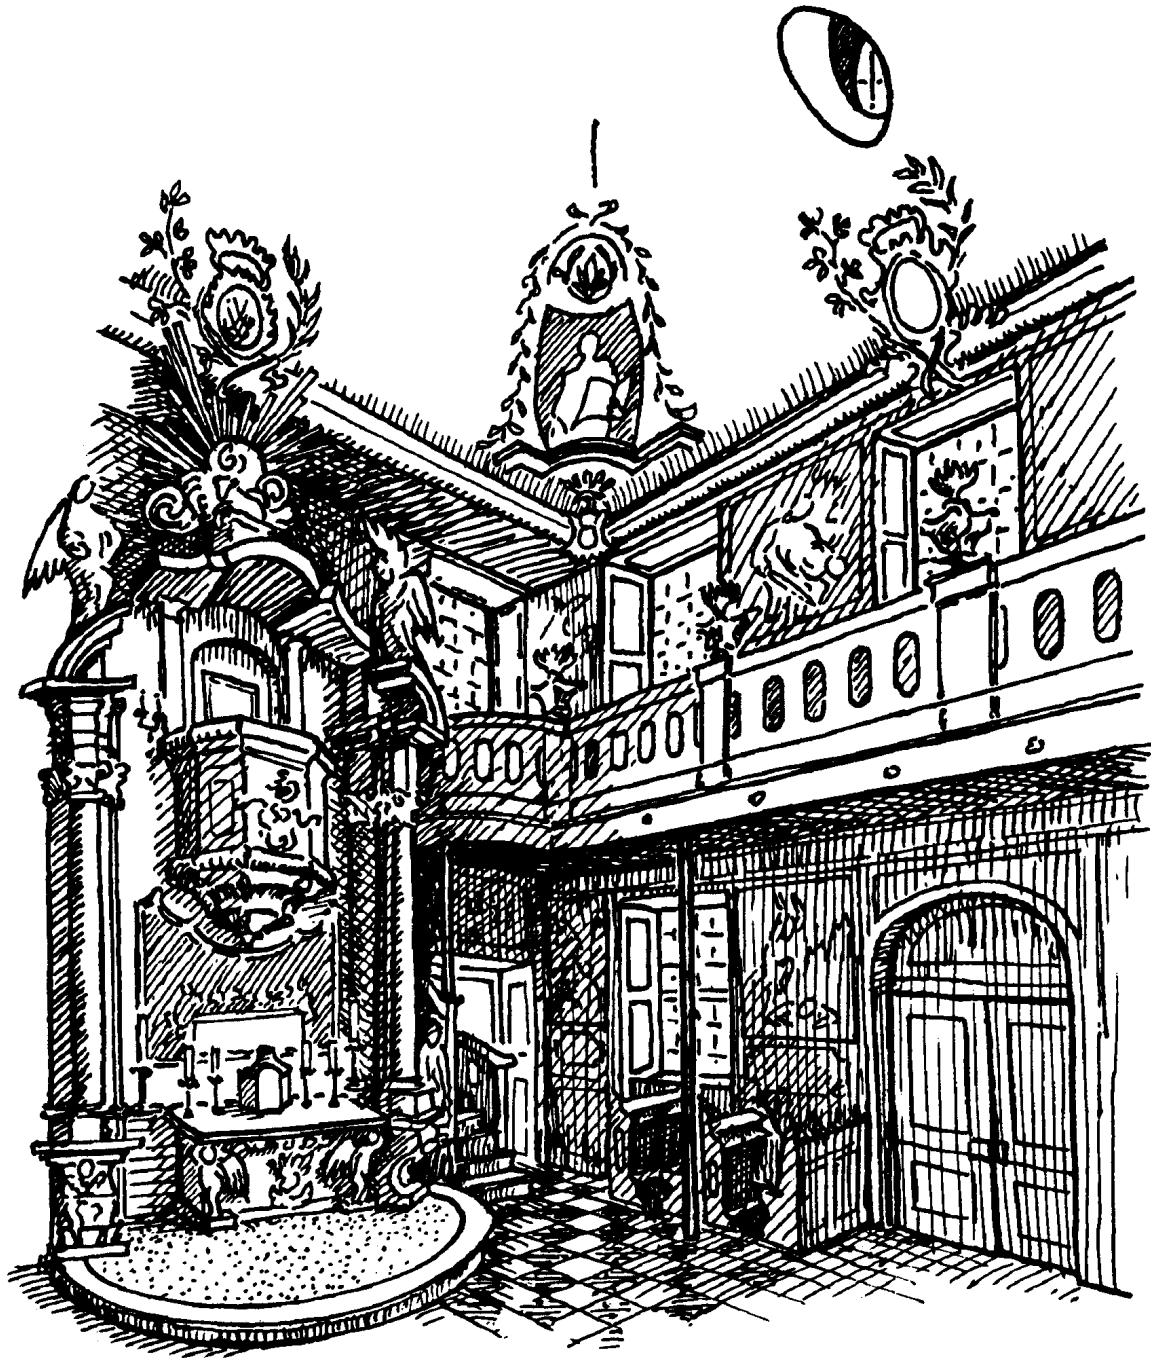
Ledreborg house has hardly altered since the eighteenth century. The chapel (fig. 1) is a baroque room with stone floor and painted wooden panelling covering the walls. The room occupies the full width and height of the west end of the main house. The construction is massive brick, cement rendered on the outside and lime plastered on the inside. The main rooms are wood-panelled.

Fig.1 The chapel of Ledreborg, looking north west. Notice the outside door opening directly into the chapel and another outside door on the balcony. The windows are large and single glazed: There is relatively free air circulation to the loft through the holes made for the oval ceiling windows. The furniture is varnished wood, the floor is stone. The room is poorly sealed against air exchange, uninsulated and poorly buffered against RH variation.

The best way to secure the stability of the paintings is to improve the climate in the chapel by reducing air leakage and heat flow. The sealing around doors and windows can be improved. The daily temperature cycle can be reduced by minimising heat flow through the windows, by the use of heat reflecting curtains or, more controversially and expensively, by adding a layer of coated, though colourless, glass to reflect radiant energy.

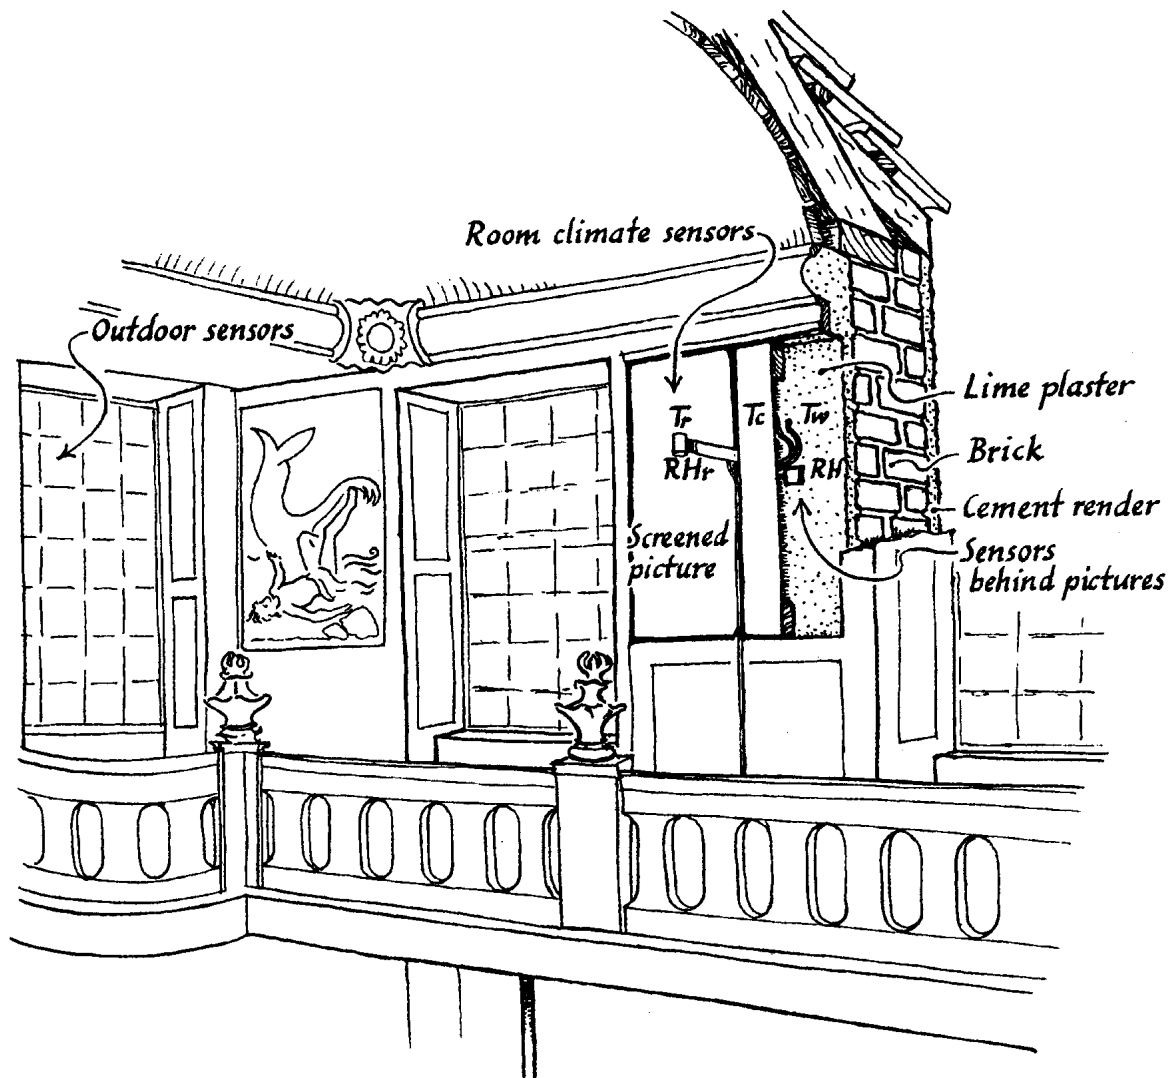
The chapel has oil paintings set in shallow recesses in the outer walls (fig.2). The conservators who have responsibility for the paintings were worried about the development of a damaging microclimate behind the pictures. The urgency of a climate study was reinforced when a large fruiting body of the dry rot fungus, *Serpula lacrymans*, was found clinging to the back of a canvas that was removed for conservation. We used this stimulus, and the availability of the wall niche, to measure the climate in the room and behind two paintings which were made to replace the original while it was under restoration.

The two pictures were set side by side in the recess, as shown in Fig.2. One of the paintings had polyester foil stretched across the back of the stretcher to prevent water vapour transfer (but not heat transfer) from the wall. Temperature and humidity sensors were placed in front of these pictures and in the air space between the canvas and the wall. The outside climate was measured in a shaded spot on the flat roof of the west wing, just outside the chapel.

Fig 2. A diagram showing a section of the wall and the positions of the climate sensors. The room temperature and relative humidity are measured at the end of a post sticking 200 mm out in front of the paintings. Behind each painting are two temperature sensors (thermocouples) touching the surface of the canvas and the surface of the wall respectively. Temperature and relative humidity sensors are enclosed in a radiation shield in the middle of the air space behind each picture.

Biological deterioration is a more urgent problem. The danger from dry rot in the roof timbers migrating to the back of the picture while trying to disperse its spores in free air will continue as long as damp conditions prevail where the roof springs from the walls. This matter is at present being attended to. There remains one other biological threat: The protected bats of Ledreborg should be dissuaded from setting up home behind the pictures. A permeable but tightly woven polyester cloth stretched over the back of the paintings' frames should serve this purpose without causing unexpected side effects.

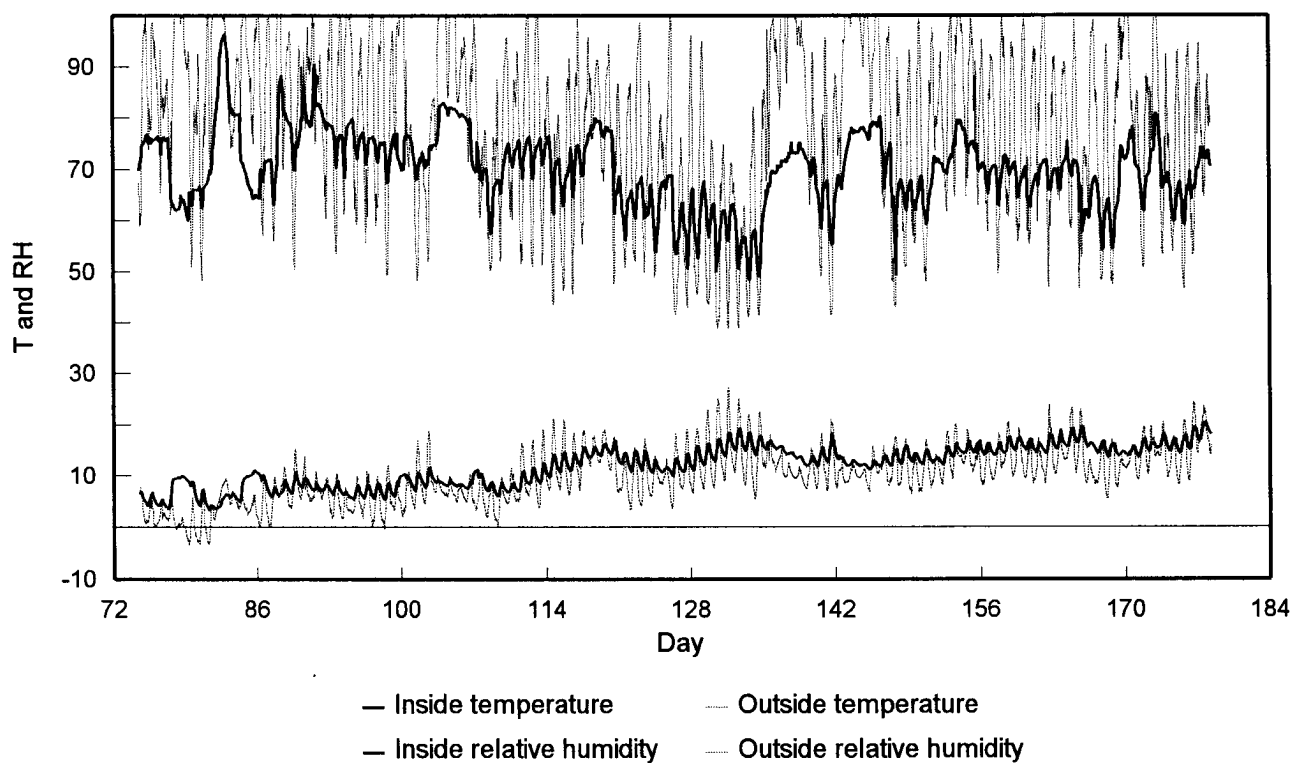
Ledreborg chapel
Temperature and relative humidity inside and outside

The climate measurements are summarised in three graphs. Figure 3 shows the outside (dotted) and inside temperature and relative humidity (RH) for a 15 week period starting on the 14th. March 1994. The inside relative humidity is generally a moderated version of the outside RH. The daily cycles of RH are caused mainly by the daily temperature cycle acting upon room air that is rapidly exchanging with outside air. The outer door has no lobby, the door at the balcony level is poorly fitting and the windows are not particularly airtight. The room is high and open, encouraging convective air exchange (the "stack effect").

The temperature and humidity cycling is not effectively damped out by the room. The abundant wood panelling is a fairly good thermal insulator, reducing the stabilising influence of the thermal inertia of the wall. The paint on the wood prevents moisture movement which would stabilise the relative humidity.

Fig.3 Temperature and relative humidity inside the chapel (bold line) and outside (dotted line). Notice the relatively poor relative humidity buffering of the room air, due to rapid air exchange through windows and doors, combined with varnish on the woodwork, which prevents humidity buffering.

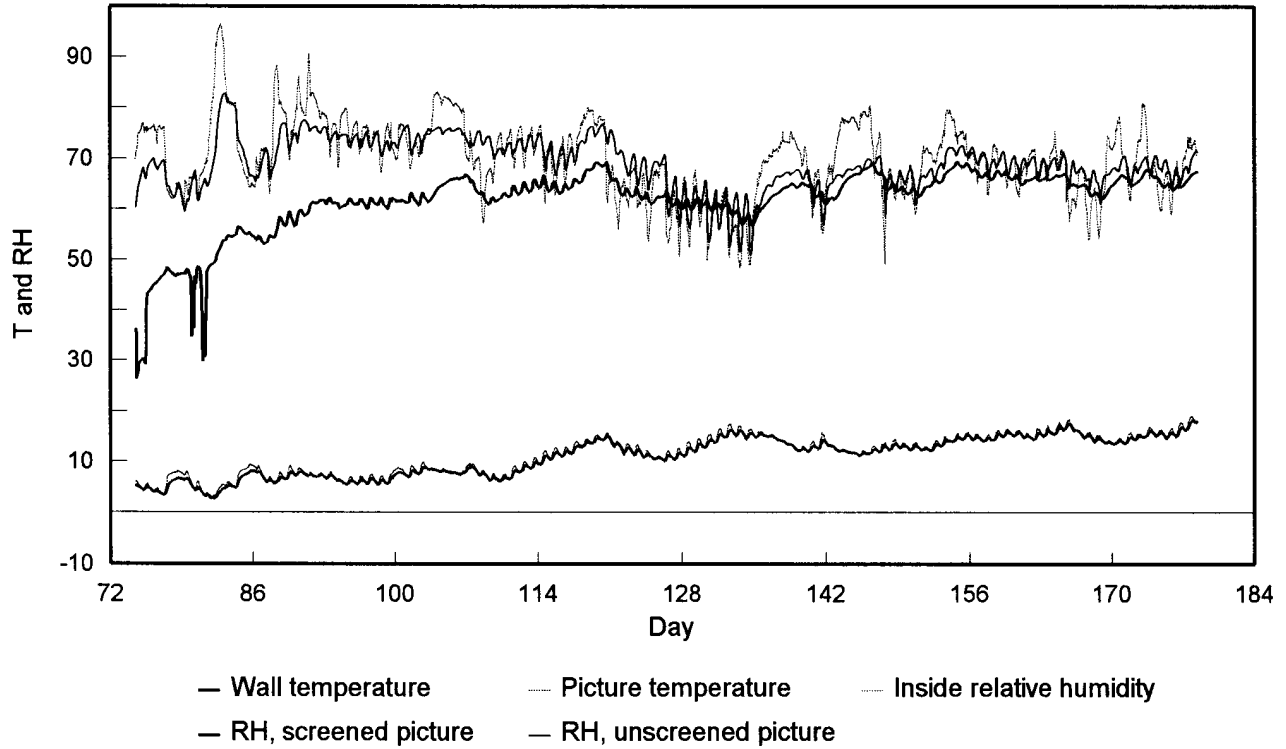
Ledreborg chapel
Relative humidity behind the pictures

Figure 4 shows the microclimate around the paintings. The upper curves show the RH in the room (dotted) and at the back of each of the two experimental paintings. Both the polyester-protected canvas (bold line) and the unprotected canvas (thin line) had been stored for several weeks in a room at about 40%RH. The unprotected canvas came rapidly to equilibrium close to the running average of the RH in the chapel, while the protected canvas came slowly to equilibrium with its new surroundings over a period of about two months. At the end of the measuring period the two RH traces have converged. The RH behind both canvases is more stable than that in the room.

Fig.4 Relative humidity in the chapel (dotted line) and behind the two pictures. The bold line is the RH calculated for the canvas back surface of the picture screened from the wall by polyester foil. Notice the slow climb in RH from the value in the conservation laboratory, about 40%, to equilibrium with the chapel after about two months. The dips at the beginning of the record are instrument failures. The thin continuous line is the RH calculated for the canvas of the unscreened picture. It follows the running average of the room RH, with a noticeable buffering, caused not by the canvas itself but by the wall.

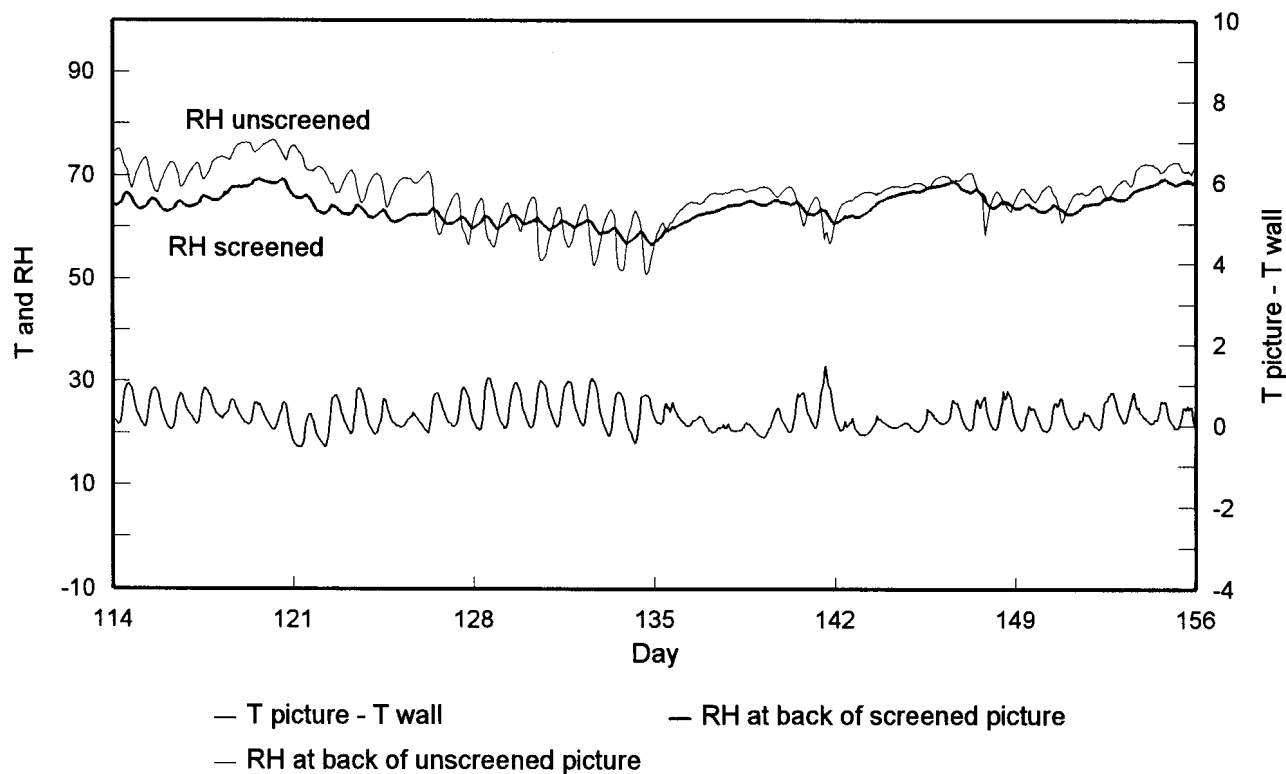
Ledreborg chapel
RH behind the pictures and temperature difference between picture and wall

The lowest line in fig.5 is the temperature difference between the pictures and the wall surface (the two pictures have identical thermal environments). Notice that the RH behind the unprotected canvas (thin line) is cycling up and down with minimum values that coincide with maximum values of the temperature difference between the picture and the wall (the picture surface is warmer than the wall surface). At first glance this could be attributed to air exchange with the room, because the RH in the room goes up and down in the same pattern. However, a closer look at fig.3 shows that the relationship between RH in the room and

These observations can be explained by assuming that the wall is controlling the RH to a constant value *at the wall surface*. This air then convects away from the wall to the back surface of the painting, keeping the exact water content it acquired when it came to equilibrium with the wall surface. Because the picture canvas is at a higher temperature than the wall, the air warms up and therefore drops in relative humidity.

This explanation may seem very indirect and speculative but it is supported by a consideration of what happens at the back of the protected painting (thick line in fig.5). Here the wall plays no part in the moisture transfer, because of the impermeable polyester sheet which separates the wall from the air space behind the picture. The air trapped behind this picture exchanges water vapour only with the canvas of the picture itself, so the RH at the back of the screened picture is much more constant. There is just a slight increase of RH as the temperature rises, which is a known property of cellulosic fibres in a confined, nearly airtight space.

The opposite pattern of the RH cycle behind the unscreened painting confirms that the reasonable RH stability cannot be due to poor air circulation, because this would allow the canvas to buffer the RH just as it does for the screened picture. The wall is actually such a powerful stabiliser of RH that it overrides the influence of the canvas.

Fig.5 The two traces at the top are the RH behind the two pictures. At the bottom is the temperature difference between picture and wall. The screened picture (bold line) has small RH peaks that approximately coincide with temperature peaks at the canvas. This RH pattern is characteristic of a closed container filled with abundant buffer, in this case the canvas. The unscreened RH (thin line) has larger RH peaks when the temperature difference is at a minimum. This can be attributed to buffering of RH by the wall *at the wall temperature*. This buffered air warms up to the canvas temperature with consequent fall in RH.
