SUMMARY

CONDITIONS IN THE COLLECTION OF ANTIQUE MUSICAL INSTRUMENTS

OUTER SHADING AND ITS EVALUATION

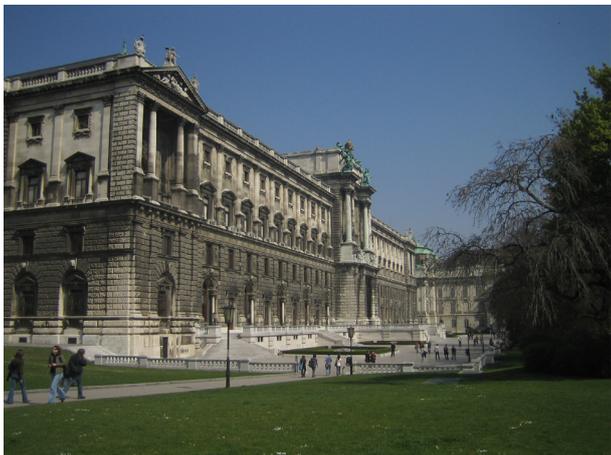
Figure 1. The Collection of Antique Musical Instruments (SAM) is located on the second floor of the Neue Burg. Its 22 windows face the south-east.

The Sammlung alter Musikinstrumente (SAM, Collection of Antique Musical Instruments) of the Kunsthistorisches Museum in Vienna, the oldest and one of the most important collections of its kind, is located since 1965 on the second floor of the Neue Burg, with 22 big chest-windows (each around 3.7m²) facing the south-east (fig.1). Semi-transparent sun protection foils, mounted inside the exhibition rooms, brought about surface temperatures up to 40°C and indoor temperatures rising up to 30°C in summer. Because of extreme climatic problems also in winter, and therefore serious damage on almost all objects made of organic materials, the collection had to be closed and refurbished between 1988 and 1991/93. In consideration of the facts and problems mentioned above, a sophisticated sun protection concept was developed after three years of measuring, observing and comparing. The physically most effective solution – an outer shading system – was forbidden due to the cultural heritage status of the building. All windows were thus equipped *within* the chest space as follows (fig. 2):

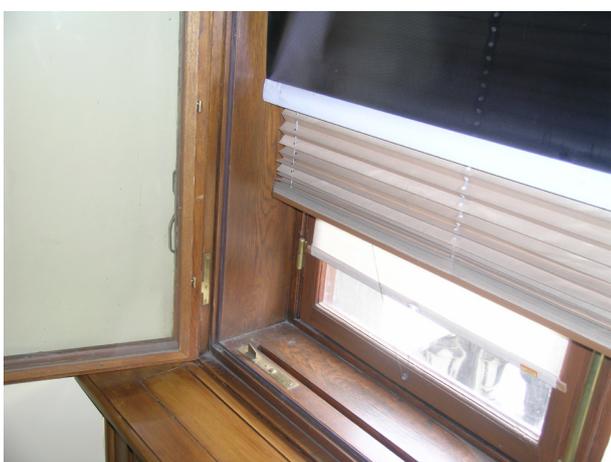
Figure 2. Sun protection measures in the windows of the Collection of Antique Musical Instruments.

1) A roller blind, made out of close-woven linen/cotton was fixed just behind the outer pane (first plane of absorption).

2) A zigzag-folded aluminium-coated sheet of polyester, (57% reflection, and 6% transmission) was mounted in the middle of the window-chest and motor-operated.

3) A silver-coated foil of polyurethane (85% reflection) was mounted next to the inner pane.

4) The window space was ventilated diagonally through a slot in the windowsill and through the opened outer flap of the fanlight (both are shut in winter).

5) The heat-flow from the window into the room, caused by the absorption on the sun protection devices, was minimized by a so-called “3rd pane” – a glass pane mounted in a wooden frame like an additional casement window and screwed tightly to the inner window frame, thus reducing the U-value by 25 to 30% [1].

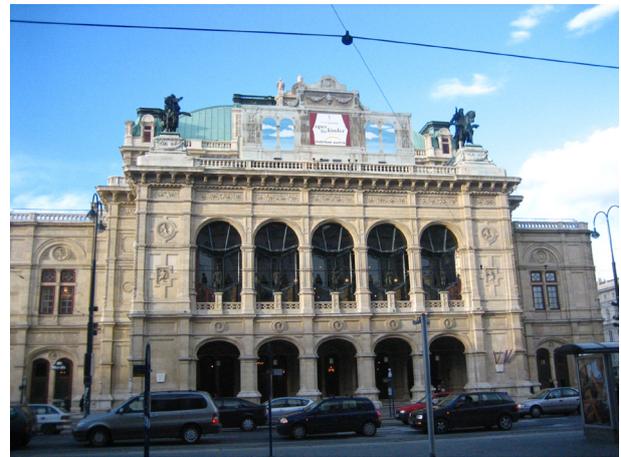
Figure 13. During winter, the arches of the loggia of the Wiener Staatsoper are closed by a movable glass construction.

1) During winter the arches of the loggia of the Wiener Staatsoper are closed by a movable glass construction

to protect the visitors of the famous “Opernball” from outside temperatures (fig. 13).

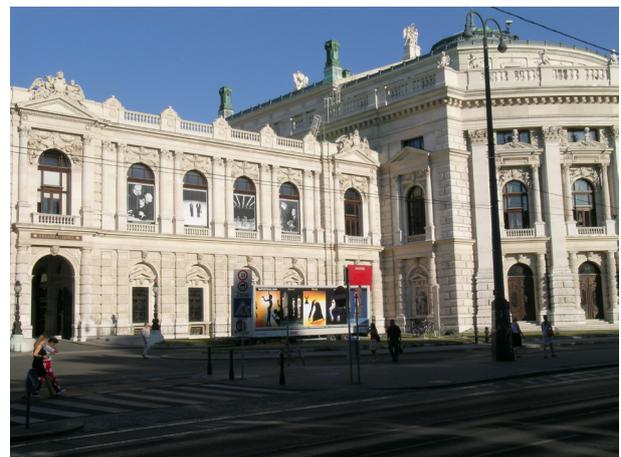
Figure 14. Eight windows of the main facade of the Wiener Burgtheater are covered up with big photographs of actors.

2) Eight windows of the main façade of the Burgtheater are covered up with big photographs of actors (serving as an optimal sun protection for the stair-case and gallery, fig. 14).

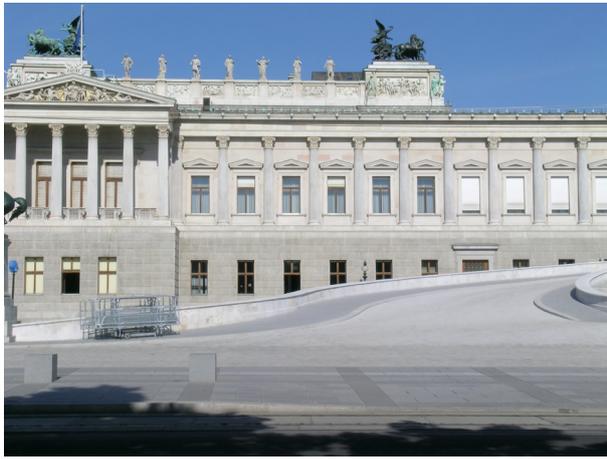
Figure 15. Twenty-six windows of the main facade of the Parliament are supplied with outer shading by means of plastic roller jalousies.

3) Twenty-six windows of the main façade of the Parliament are supplied with outer shading by means of plastic roller jalousies to protect our representatives from over-heating (fig. 15).

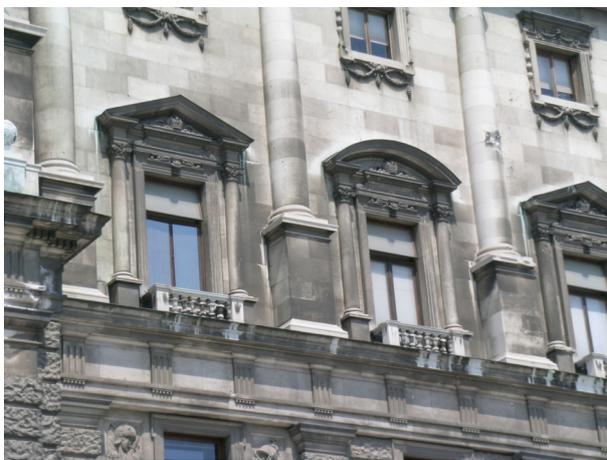
Figure 16. Prototype of the optimized outer shading (left) next to the situation since 1991 (middle) and a PC-pane without coating but with an expanded metal blind behind it, mounted in a frame in front of the window (right).

In comparison with these examples, the proposal for the SAM looks very inconspicuous: Fig. 16 and 17 show the prototype of the optimized outer shading (left) next to the situation since 1991 (middle) and a PC-pane without coating but with an expanded metal blind behind it, mounted in a frame in front of the window (right). The frame has to be fixed in a distance of c. 20mm for cooling the pane by convection. Because of the high extension-factor of PC (0,07mm/°C/m) the pane has to be mounted “swimming” in the frame. It is important for an “invisible” construction that the frame holding the pane has the same colour as the window frame and that the inner contour of the shading frame follows the visible dimensions of the glass pane (without the putty rabbet), so that reflecting and non-reflecting parts, seen from below, show exactly the same dimensions as the other windows of the building without outer shading.
