# HOW TO DESIGN MUSEUMS WITH A NATURALLY STABLE CLIMATE

Tim Padfield and Poul Klenz Larsen

*This article is an extended version of the talk given by Tim Padfield to the Annual General Meeting of the International Institute for Conservation, January 2004.*

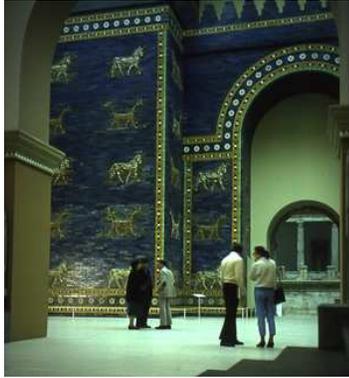
Figure 1: The Pergamon Museum, Berlin. The huge Assyrian reliefs are housed in an immense building in neo classical style. Built in 1920–1930. Architect: Alfred Messel.

Until the first quarter of the twentieth century, gravity defined the practical limits for the appearance of a building and gravitas described the appearance of museums. In the Pergamon Museum in Berlin (Figure 1), monumental outdoor art is enclosed in an even larger structure, itself encased in a classical colonnade.

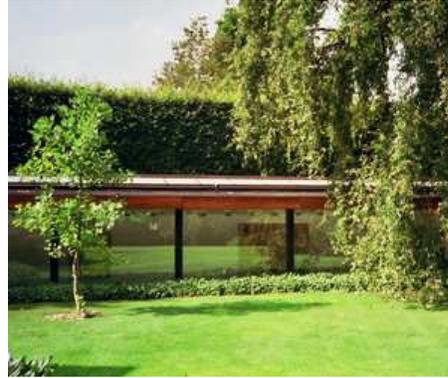
Figure 2: A gallery of the Louisiana Museum of Modern Art, north of Copenhagen, designed in the late 1950's by Wilhelm Wohlert and Jørgen Bo.

The modern movement in architecture allowed, but did not guarantee, a reaction to this portentous style. The Louisiana Museum of Modern Art north of Copenhagen (Figure 2) is one of the world's most unassuming art museums. Relief at its simplicity and human scale must be balanced against concern for the loss of secure containment. The flood of light is a visible cause of damage to the art, the lack of thermal inertia and moisture absorbing materials in the structure is both an invisible threat and a stress on the air conditioning equipment.

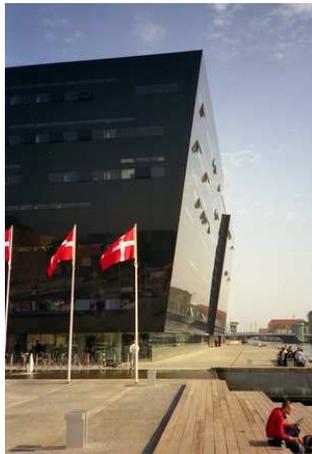
Figure 3: The Royal Library extension, Copenhagen, 1999. Designed by Schmidt, Hammer and Lassen.

Architects have used the new science of accurately computed tensile constructions to make their mark with walls falling outwards at previously impossible angles, as in the The Royal Library in Copenhagen (Figure 3). This trend to press architecture to the limit, to make the enclosure for art itself the major artistic attraction, rather than just a sympathetic container, is exemplified by Frank Gehry's Guggenheim Museum in Bilbao (Figure 4).

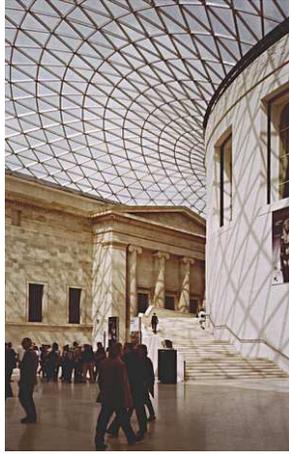
Figure 5: The recently covered courtyard of the British Museum, London. 2000. Architect, Norman Foster.

Another trend in modern museum building is the enclosure of courtyards of existing buildings (Figure 5) and the linking of old and new parts by glass corridors (Figure 6). These glass enclosures reduce the surface area to volume ratio of the building, and provide negligible thermal inertia, resulting in a need to cool the building even in winter in a temperate climate. This is a design trend made possible only by cheap energy. Half the energy from the sun is light, so clear, uncoloured glass, however technologically advanced, can at best only halve the incoming solar power. At the same time as we are urged to reduce our consumption of fossil fuels, architects are designing air conditioned buildings in northern Europe, where air conditioning was considered unnecessary only a couple of decades ago.

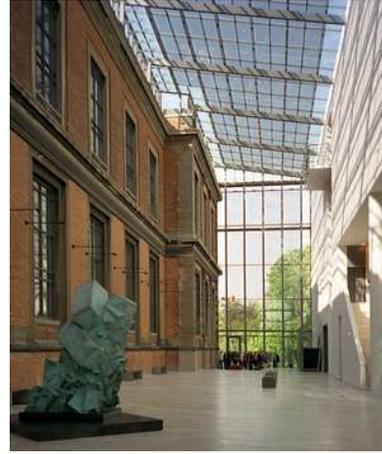
Figure 6: The Danish National Gallery, Copenhagen. The glass atrium joins Wilhelm Dahlerup's building from 1896 to the extension designed by Anna Maria Indrio, opened in 1998.

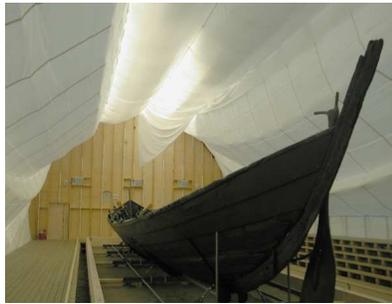
Figure 7: The Nydam Boat, exhibited in an inflated structure but here shown in the middle of a power cut. Fortunately, the wires holding the condensation collector above the boat also held the entire canopy when the air pressure failed. Architect KHRAS. Photo: Ole Vanggaard.

caring for artifacts. The Nydam boat, from the fourth century AD, normally enjoys a quiet retirement in Gottorp House in Schleswig. It was lent recently to the National Museum of Denmark which put it under an inflated structure (Figure 7). The thin envelope gives scant separation between the northern European climate and the warm humidified interior, so condensation dripped from the roof. The engineers then strung wires from end to end to hold a canopy to catch the drips. The wires also held the tent from falling into the boat when the power to the pumps failed. We must be thankful for the serendipitous modification which both deflected an unforeseen threat and prevented an unexpected disaster.

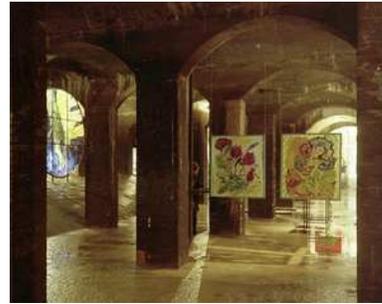
Figure 8: The Museum of Modern Glass Art is housed in an abandoned cistern under a low hill in Copenhagen. The shine on the floor is water.

Massive construction, however, is not a guarantee of a good climate. The Copenhagen Museum of Modern Glass Art (Figure 8) is in a reservoir built within a low hill, which once provided water to the city. Here, one cannot criticise the immense thermal inertia of the semi-infinite walls but the relative humidity is not ideal, though its stability is ensured by the constant centimetre of water all over the floor.

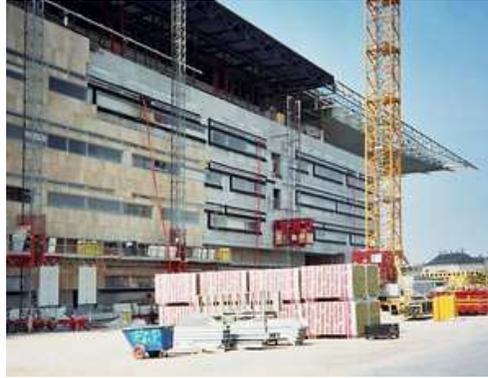
Figure 9: The Copenhagen Opera House, designed by Henning Larsen, seen under construction in 2003.

The construction methods and materials of modern buildings are now uniform worldwide. Even a prestige building, where there is no pressing need to save money, pays scant regard to local materials or adaptation of building style to the local climate. The Copenhagen Opera House (Figure 9) provides a visual list of the universal ingredients of a building: steel, precast concrete slabs, mineral wool insulation, glass, gypsum board, plastic paint and a thin surface veneer, in this case sandstone tiles. None of these materials has significant exchangeable moisture content and only concrete provides thermal capacity. In modern buildings it is only thermal insulation that counts. Until the last few years, national building regulations for minimising energy consumption have specified the thermal insulation required in a house. It is only very recently that the regulations in some countries have allowed a calculation of performance based on energy consumption, rather than thermal insulation.

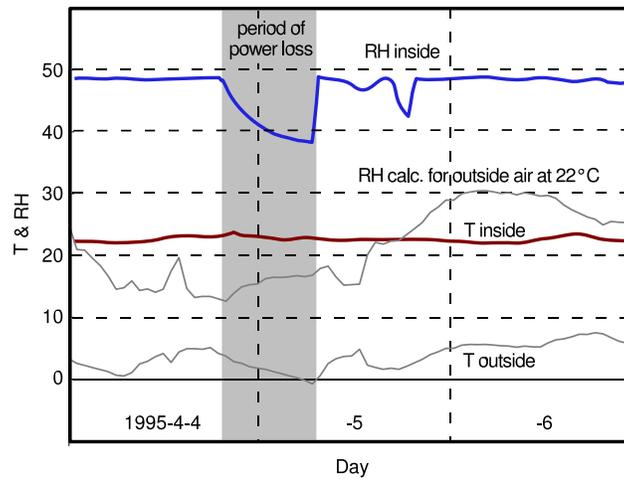
Figure 10: The course of the climate in a gallery of the National Museum of Denmark. During a twelve hour power failure the massive building held a steady temperature but the relative humidity descended steeply from its artificially high value towards the value corresponding to the outdoor air raised to the indoor temperature.

Heat and moisture movement are inextricably interdependent in buildings. Our example comes from the only source of information on the natural performance of modern buildings: what happens when the power fails and the data logger is battery powered, or clockwork driven. The part of the National Museum of Denmark whose climate during a 12 hour power cut is shown in Figure 10 is made of concrete and brick. Heating is by air circulating within the concrete floors. The original courtyard has been covered to make a large room for temporary exhibitions. When the power failed the temperature remained high because of the great thermal inertia but the relative humidity fell, because the cold outside air with a low water vapour concentration filtered into the building through the windows. We learn from this that thermal inertia is not protective of the art without corresponding moisture inertia. The exhibits in this room were mostly behind glass, the walls were painted with acrylic emulsion and the floor was varnished wood. There is hardly any moisture buffering in this room to defend it when the mechanical humidification fails.

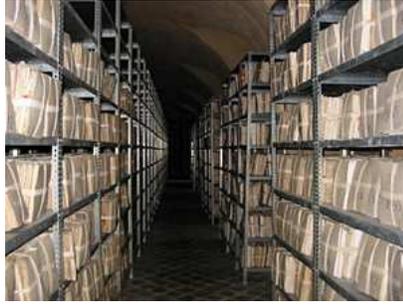
Figure 11: The military archive of the Castle of Segovia in Spain. On one side the room is bounded by the massive limestone of the castle rock. On the other side, small windows penetrate the massive outer wall. Photo: Victoria Smith.

We show first the data for the military archive of the castle of Segovia in Spain, a room (Figure 11) with enormous thermal and moisture inertia, having the massive limestone of the castle rock as the floor and one wall and a mass of paper records as its contents (Figure 13). Note how the thermal buffering also holds the RH steady, towards the right hand end of the graph, where the outside RH decreases swiftly, but the inside RH actually increases slightly, because the water content of the warm outside air increases as summer approaches.

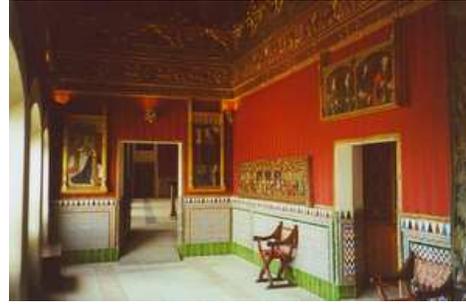
Figure 12: The Cord Room, on the exhibition circuit at a higher level in the Castle of Segovia.

We turn now to the climate of an exhibition room in the upper part of the castle, with visitors, good ventilation and relatively sparse furnishing (Figure 12). The corresponding climate data (Figure 14) are much more typical of a museum, yet we can still see a considerable reduction of the RH cycle amplitude, compared with the outdoor values.

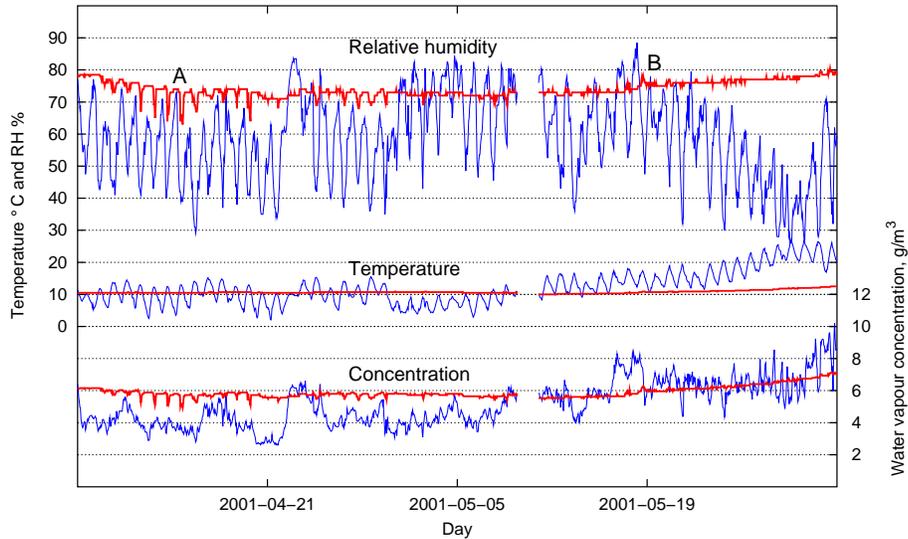
Figure 13: The microclimate in the military archive (bold lines), compared with the outside climate. The point **A** on the RH trace marks a period when opening a window during working hours pushed the RH to a lower value. At point **B**, in warmer weather, opening the window increased the RH. Data from Victoria Smith [3]

We can also note some support for the assertion that moisture buffering is easily overpowered by air exchange. There are some downward blips in the RH record at the beginning of the sequence. These are caused by the curator opening the window as she starts work, and locking it again before she leaves. Each event leaves the RH a little lower, after the initial rapid recovery. As summer approaches, the curator's ventilation has the opposite effect, causing the RH to rise in small steps.

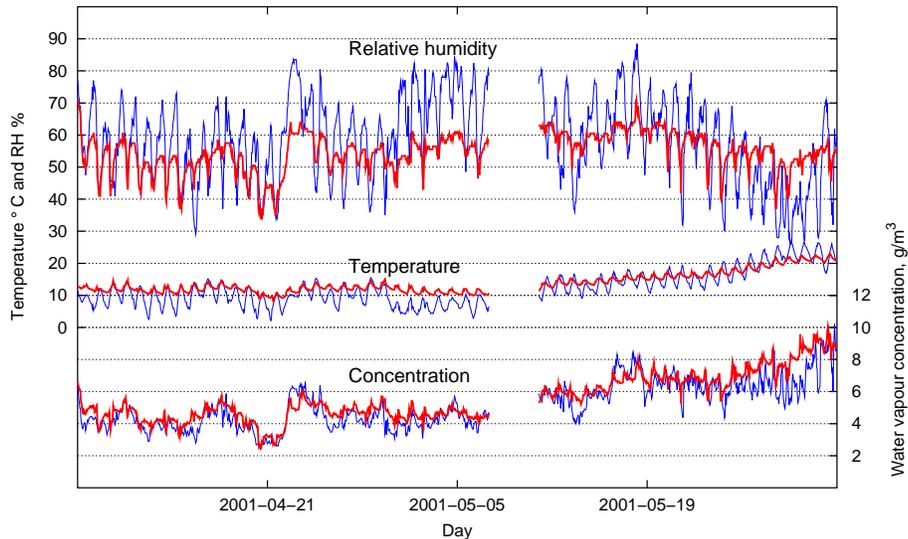
Figure 14: The climate within the Cord Room, compared with that outside. Note that the water vapour concentrations are not identical, indicating that the RH is not buffered by thermal inertia alone. Data from Victoria Smith [3]

Our interpretation of the cause of the moderation of the interior RH is limited by a fundamental ambiguity. We can see immediately that the smaller cycle in

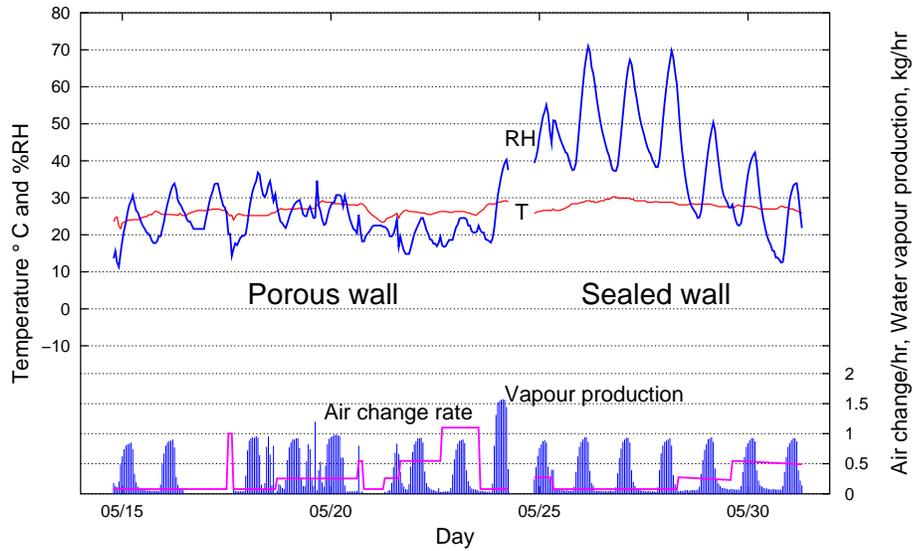
Figure 15: The climate within an experimental room in Tapanila ecological house, Espoo, Finland. During the first period, a humidifier blows water vapour intermittently into the room which has porous walls. During the second period, the walls are covered with polyethylene sheet. The ventilation rate is varied throughout the experiment. The better buffering with the porous walls is quite clear. Data re-plotted from Rode et al. [4].

We have thus reached the end of the road in reporting quantifiable experience from museums. The only precise measurements of humidity buffering with a known air exchange rate and moisture flux come from experimental rooms designed to improve the comfort of humans rather than of inanimate art. Figure 15 shows the course of the climate in Tapanila ecological house, Espoo, Finland. Similar results are reported from the Fraunhofer Institute for Building Physics in Holzkirchen, Germany (Figure 16) [5]. The expected effectiveness of wooden buildings in buffering the relative humidity with various rates of air change has been modelled by Simonson and co-workers [6].

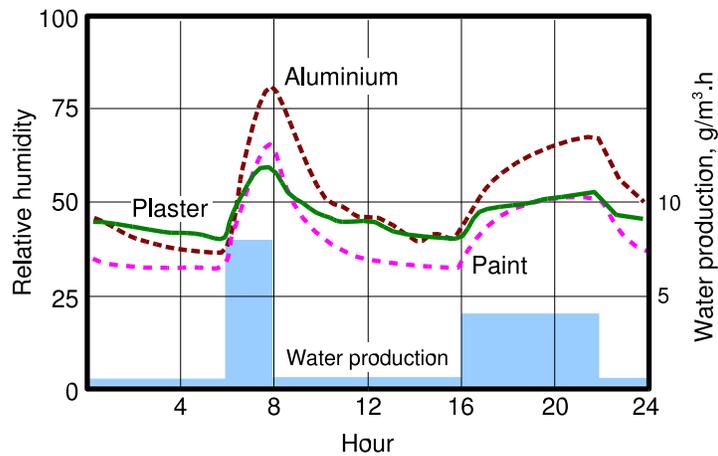
Figure 16: The climate within an experimental room at the Fraunhofer Institute for Building Physics in south Germany. The plaster walled room was compared with a similar room with aluminium walls and was finally painted. The porous bare plaster wall gives significant buffering against the typical daily water vapour production of a family. Data re-plotted from Holm et al. [5]

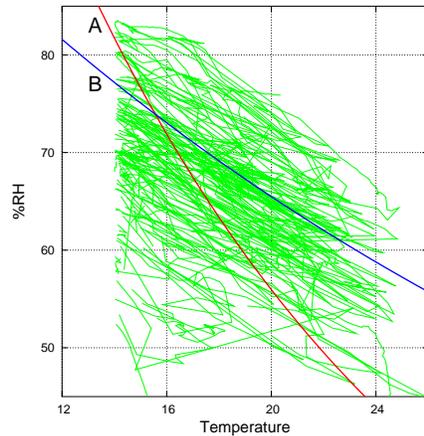
Figure 17: The overlapping cycles of RH against temperature in Gundsømagle Church, Denmark, during many periods of heating and cooling. If the walls were inert to moisture, the traces of the temperature cycles should lie parallel to the steep curve **A**, which marks the course of the RH as the temperature varies in an isolated space. In fact, the porous limestone walls buffer the RH, so it follows a set of shallower cycles, whose average gradient is shown by the flatter curve **B**. The angle between these two curves can be considered a figure of merit for buffer performance. Data re-plotted from Eshøj [7].

some quantitative idea of this effect we chose, as before, data that come from an unintended experiment. In Gundsømagle Church in Denmark, the temperature in winter is normally kept at about 12°C. The church is warmed for services and for the organist to practise. We have extracted from the climate record for one year just these brief periods of warming and cooling and have plotted the data as superimposed cycles of temperature against RH (Figure 17). Given an air change rate that is slow compared with the period of the temperature change, we can assume that an inert wall would result in a relationship between temperature and RH given by the steep bold curve in the diagram. This expresses the fact that a rise in temperature will cause a fall in RH in an isolated volume of air. The observed variation, averaged over many heating and cooling events, follows the shallower curve, indicating that the RH is not varying as much as it would in the room with moisture inert walls. As the temperature rises, the wall releases water vapour to maintain the RH, and absorbs it again as the temperature falls. If the walls were to buffer perfectly, the plot would be a maze of nearly horizontal lines. The angle of the squiggly lines to the horizontal can therefore be used as a figure of merit for RH buffering by the walls. This value is unique to the room, not to the material of the wall, because it is affected by the area to volume ratio. Experimentally, this is not an ideal method, because the thermal inertia of the wall interferes, reducing the moisture buffering effect.

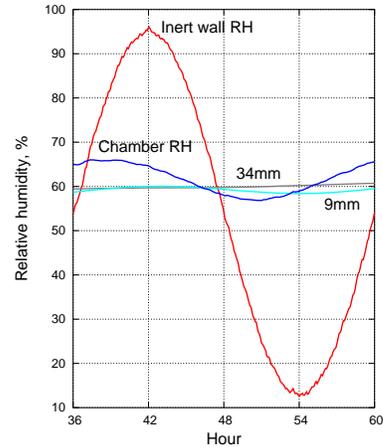
Figure 18: The RH buffering provided by  $0.3 \text{ m}^2$  of lightweight clay plaster in a test chamber of  $0.5 \text{ m}^3$ . The large curve is the expected RH in the empty chamber, as a response to addition and withdrawal of water corresponding to the daily cycle of water production indoors and loss of water vapour by ventilation. The flatter curves are the measured RH within the chamber when the clay plaster was present and the RH measured at two depths within the plaster. From Padfield [8] page 76

So far, we have discussed the performance of building materials that have not been chosen deliberately for their buffering capacity. Padfield [8] has experimented with optimising wall surfaces for moisture buffering, while retaining a smooth appearance, easy application and low cost. Figure 18 shows the buffering afforded by a lightweight, clay bonded plaster, designed to be a substitute for gypsum plaster as an indoor finish. The experimental conditions were broadly similar to the previously reported small room experiments, with a sinusoidal cycle of injection and withdrawal of water vapour but with no air exchange. The expected daily RH variation in an inert room is shown by the steep curve. The flatter curves show the measured RH in the chamber and at depth within the plaster surface. Not only is the buffering impressive but the thickness of buffer that is affected is only about one centimetre. This limits the ability of the buffer to counteract the influence of rapid air exchange, but it also means that a thin layer is also the optimal thickness for buffering the daily variation in RH.

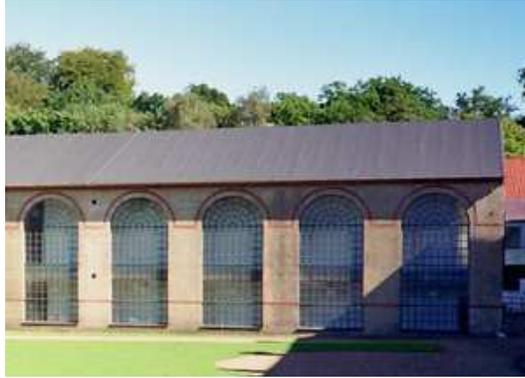
Figure 19: A museum store in Brede, north of Copenhagen. A new, thermally insulated, airtight and moisture buffering room has been built within an old machine hall, leaving a corridor between the old shell and the new room. Climate control is by heating and by pumping outside air into the room when the water vapour content is suitable.

Figure 19 shows a storage room at the National Museum of Denmark, glimpsed behind the original factory windows. The walls of the room are airtight and thermally insulated against the corridor which surrounds three sides. The air conditioning is by pumping air from the corridor, which is not sealed against entry of outside air, into the room when the air has by chance the right water vapour content to drive the room air to the desired 50% relative humidity. The air is sometimes heated as it is pumped in, so that the temperature in the insulated room drifts according to the time of year. In the winter, however, the air in the corridor is heated to 12°C, so the room also holds this constant temperature.

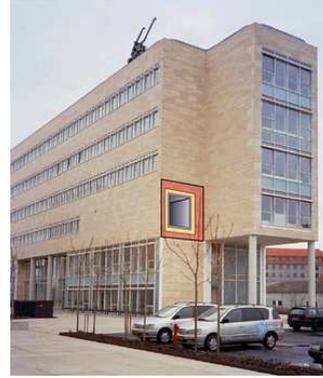
Figure 20: A building of Copenhagen University, holding the archive of the Arnamagnæan Institute. The end wall of the archive is removed to show schematically the heavier insulation towards the interior of the building, the massive concrete wall and the cellular concrete humidity buffer.

Another variant is used in an archive in Copenhagen University [11]. Figure 20 shows the building, with the end wall of the archive removed to show how the insulation is arranged with a thinner layer towards the outside of the building and thicker insulation towards the inside. The carefully calculated insulation thicknesses, together with the thermal inertia of the massive concrete walls, hold the air in the archive at a temperature about half way between the central corridor of the building, always at about 20°C, and the running average of the outside temperature. This will give a yearly average RH of about 50%, but only if the buffer capacity of the room and its contents is used to even out the annual climatic cycle. The concrete is therefore lined with expanded cement blocks to provide moisture buffering. There are not yet data to demonstrate the performance of this room over the yearly cycle.

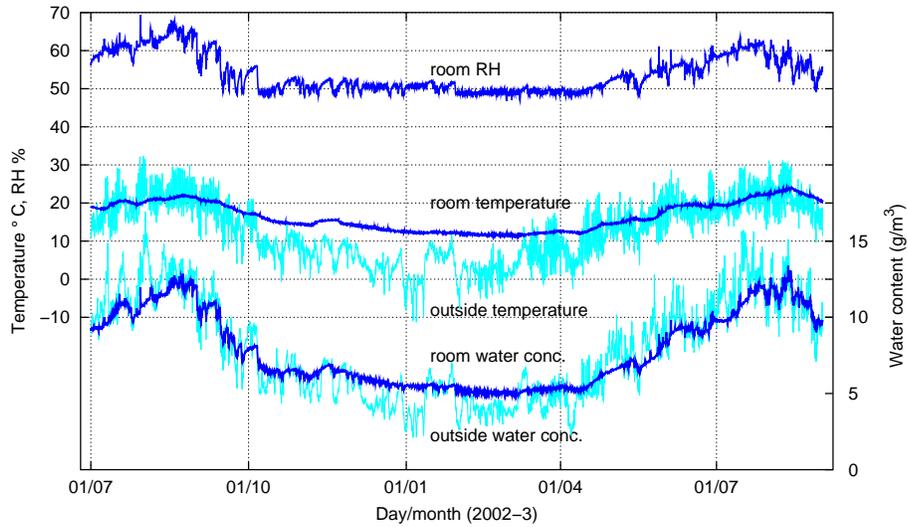
Figure 21: The climate in the Brede storeroom from July 2002 to August 2003. The set point is 50% RH. In summer the outside water vapour content is generally higher than that inside, so air is only pumped in when, by chance, the outside water vapour content dips below the water vapour content in the room (the two lowest traces). The optimal control is given by a subtle interplay of room temperature and the trend in outside temperature. One can see in the period immediately after 1/7/2003 that high outside water vapour content has resulted in a steady rise of inside RH, due to leakage but maybe also helped by rising temperature, which causes RH to rise in a well buffered enclosure. Data from Brian Simonsen [9]

system is not as perfect as can be obtained with full air conditioning (Figure 21), but it is cheap - costing about half what full air conditioning would cost to run. The initial investment is also less, because the ventilation equipment is small and simple.
